## РОЗРОБКА ТЕХНОЛОГІЇ ВІДНОВЛЕННЯ ЧАВУННИХ КРИШОК І ПОРШНІВ СУДНОВИХ ДИЗЕЛІВ

**DEVELOPMENT OF TECHNOLOGY FOR THE RESTORATION  
OF CAST IRON COVERS AND PISTONS FOR MARINE DIESEL ENGINES**

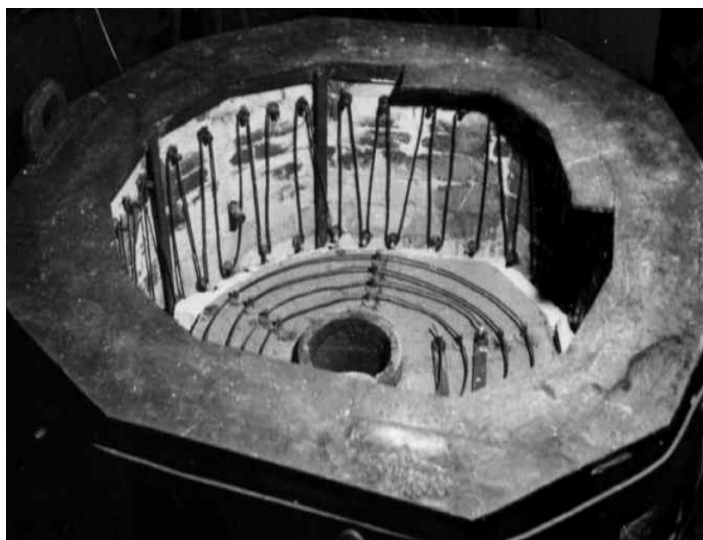
An electric furnace [1] was developed and manufactured for heating cast iron covers of MAN marine diesel engines (Fig. 1).

*Fig. 1. Electric heating furnace for MAN K6Z57/80F diesel engine covers  
(cover removed)*

Electric furnaces ensure high accuracy and uniformity of heating through the rational placement of heat sources, as well as high heating performance.

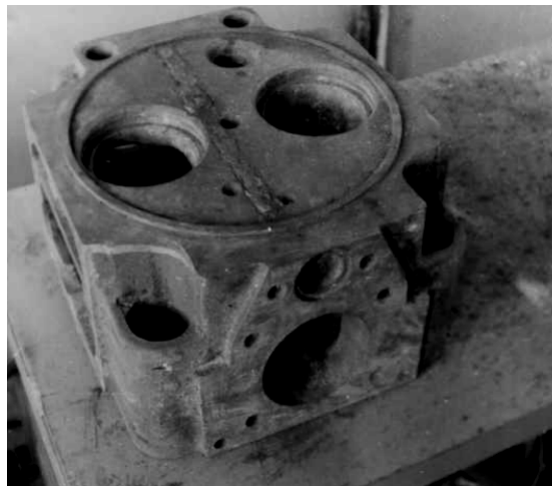
The appearance of the 6CH25/34 lids with a weld is shown in Fig. 5.

*Fig. 5. Cover 6CH25-34 with welded seam*

Visual inspection revealed longitudinal cracks in the weld and craters. Preheating the lid to 573 °K is not sufficient and further research on the initiation for repair of gray cast iron lids should be carried out at an increase in the preheating temperature to 873 °K. In addition, further research should be conducted on lids with cracks rather than on simulators with a through slit, since there are different conditions for weld pool crystallization in the simulator and a real lid with a crack.

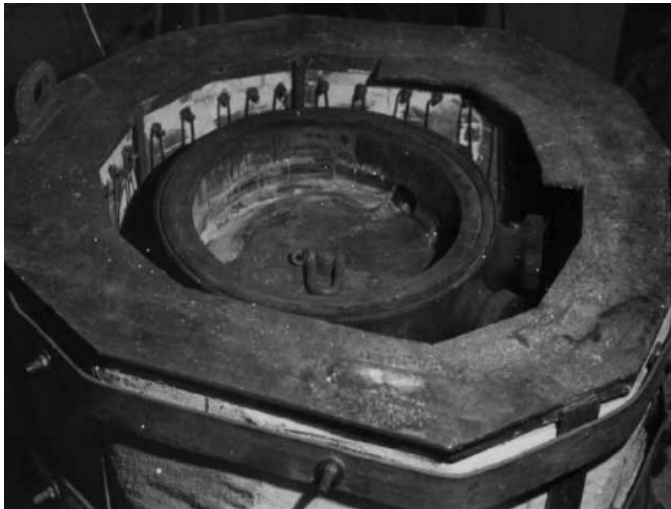
Cracks ranging in length from 50 to 30 mm were detected. The beginning and end of each crack were precisely drilled. A vulcanite wheel was used to develop the crack until it completely disappeared (the cracks were not through). The depth of development was about 15-17 mm. The lid is placed in a special electric furnace, where it is heated to a temperature of 453-473 °K (Fig. 7). Welding is performed by a semi-automatic machine with PANCH-11 wire,  $\varnothing$  1.2 mm at  $I_w = 180 - 200$  A,  $U = 19 - 21$  V.

*Fig. 7. MAN diesel engine cover placed in an electric heating furnace.  
Exterior of the repaired cover*

The surfacing is performed on individual 100 mm long rolls with mandatory forging to partially relieve welding stresses. External inspection showed the satisfactory formation of the rolls without pores, cracks, undercuts, or other defects.

The reconditioned covers were subjected to a hydraulic test for 5 minutes on a special stand. The test pressure from the side of the water cooling cavity was 10 atm. No leaks were recorded.

The presented technology for the restoration of MAN K6Z57/80F diesel engine covers made of high-strength cast iron by the reduced welding method with PANCH-11 self-shielded wire or another with the same chemical composition can be recommended for the repair of similar covers that have non-through cracks on the side of the combustion chamber up to 16-20 mm deep and no more than 500-700 mm long.

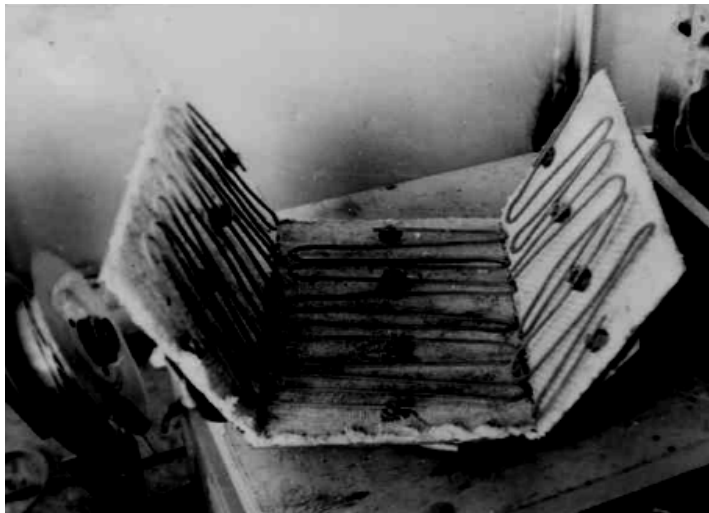
Fig. 9. Electric furnace for heating cast iron piston heads

The heating elements are nichrome wire  $\varnothing$  4 mm. The furnace is designed in such a way that it grips the piston from three sides – from the bottom and sides. There is access to the welding torch from above. The furnace frame consists of three 3 mm thick steel sheets welded together. The inside of the furnace is lined with a layer of asbestos; three zigzag nichrome heaters are bolted and connected in parallel. The power source is a transformer. The furnace provides a heating temperature for the pistons of auxiliary diesel engines up to 573 °K. A general view of a rotating device for surfacing cast iron pistons with an electric furnace and a piston is shown in Fig. 10.

The control scheme (Fig. 8) allows you to smoothly adjust the speed of rotation of the part. For preheating the pistons before surfacing, a heating device, an electric resistance furnace, was manufactured (Fig. 9).
