ТЕХНОЛОГІЧНІ МОЖЛИВОСТІ ВІДНОВЛЕННЯ ЧАВУННИХ ДЕТАЛЕЙ СУДНОВИХ ДИЗЕЛІВ

Анотація. Застосування сучасних методів відновлення зношених чавунних деталей суднових дизелів є одним з необхідних ресурсів в судноремонті. З чавунних деталей виготовляють складні тяжко навантажені, високоцінні базові складові дизелів, від якості ремонту яких залежить роботоздатність вузла та агрегату в цілому. Для дослідження можливостей відновлення зношених чавунних кришок і поршнів суднових дизелів було досліджено зварюваність сірих і високоміцних чавунів та проведено металографічні дослідження наплавлених поверхонь. Проведені дослідження зварюваності сірого та високоміцного чавунів на імітаторах виявили можливості відновлення чавунних суднових деталей. Одержані результати дають можливість перейти до експериментальних досліджень по розробці технології відновлення на реальних суднових деталях.

Abstract. *The use of modern methods for the restoration of worn cast iron parts of marine diesel engines is one of the necessary resources in ship repair. Complex, heavily loaded, high-value basic components of diesel engines are made of cast iron parts, the quality of repair of which affects the performance of the un

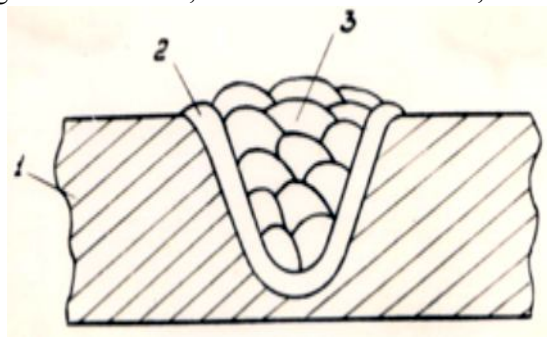
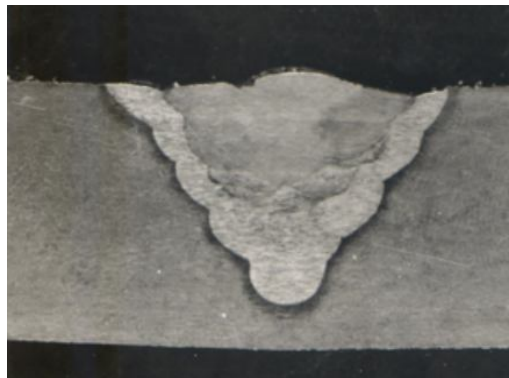
*Fig. 1. Welding joint with the cladding
a) scheme of filling the development;
b) microstructure of the weld.
1 – base metal; 2 – cladding layer; 3 – filler.*

Studies were carried out to select the most technological method [4] of cold welding of gray cast iron according to the following scheme: cladding the workpiece with PANCH-11 self-shielded wire and filling the workpiece with aggregate (Fig. 1), which was used as surfacing with MNCH-2; UONI 13/45 electrodes, etc.

When studying the weldability of gray cast iron on technological plates with a size of 500x200x28, the cladding of the development was performed by semi-automatic welding at $I_w = 150-170$ A, $U = 16-18$ V with PANCH-11 wire, 1.2 mm in diameter.

Filling of the development was performed with MNCH-2 electrodes on a copper-nickel base $\varnothing 4$ mm at a constant current of reverse polarity $I_w = 120$ A. The weld formation is satisfactory, without pores and cracks. There are some undercuts.

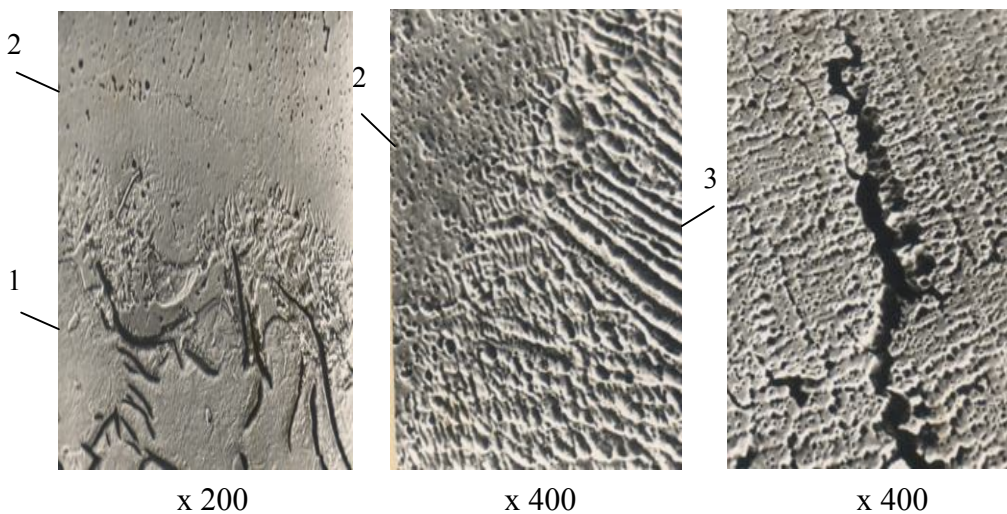
Fig. 2. Structure of weld metal with PANCH-11 wire cladding
a) the fusion boundary of the base metal and the cladding layer;
b) the fusion boundary of the cladding layer and the aggregate;
c) cladding layer.
1 – base metal;
2 – surfacing with PANCH-11 wire;
3 – surfacing with MNCH-2 electrodes

Studies of the microstructure of the welded joint showed that there are no pores and cracks in the fusion lines of cast iron with nickel and in the fusion zone of nickel with copper-nickel filling (Fig. 2, a, b). At the same time, there are cracks in the austenitic cladding layer (Fig. 2, c).

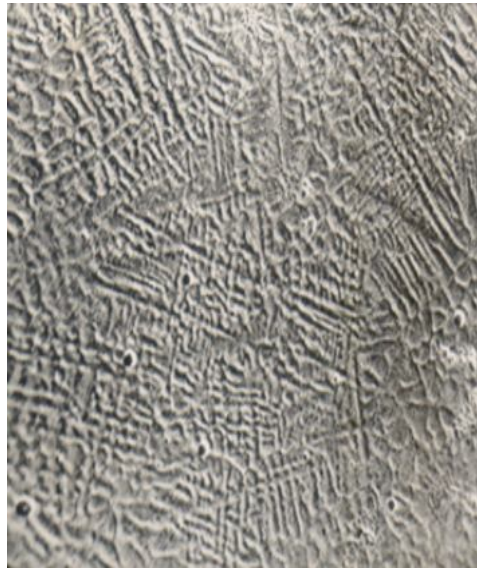
Fig. 3. Microstructure of the weld metal, where they were used as filler electrodes OZCH-2

When filling the development with OZCH-2 electrodes (surfacing was performed at a constant current of $I_w = 140$ A, reverse polarity with a $\varnothing 4$ mm electrode), due to the high low-flow rate of the iron-copper alloy, the weld formation is unsatisfactory. There are undercuts and crusting is also unsatisfactory.

It is difficult to achieve a stable process. But at the same time, metallographic studies have shown the absence of cracks in the welded joint (Fig. 3). Along the line of fusion of the cladding layer with the base metal, there are hardened structures with a microhardness of 370 N μ . Fig. 4 shows the nature of changes in the microhardness of the joint.

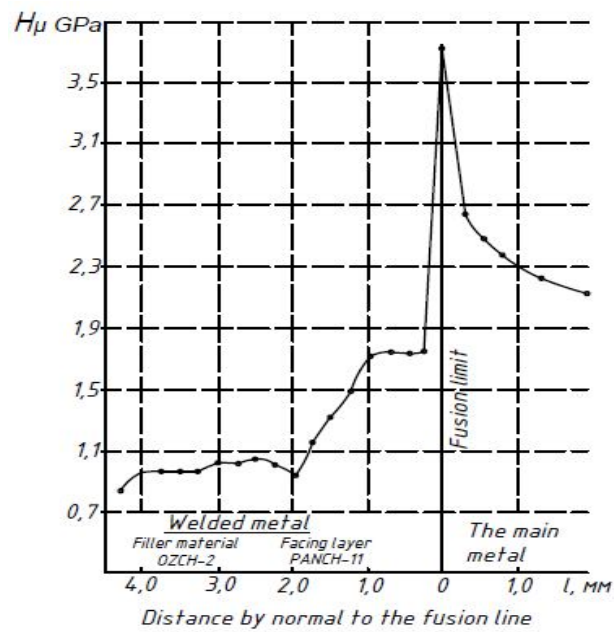
Fig. 4. Change in microhardness along the welded joint sections when surfacing with OZCH-2 electrodes:
• – experimental values

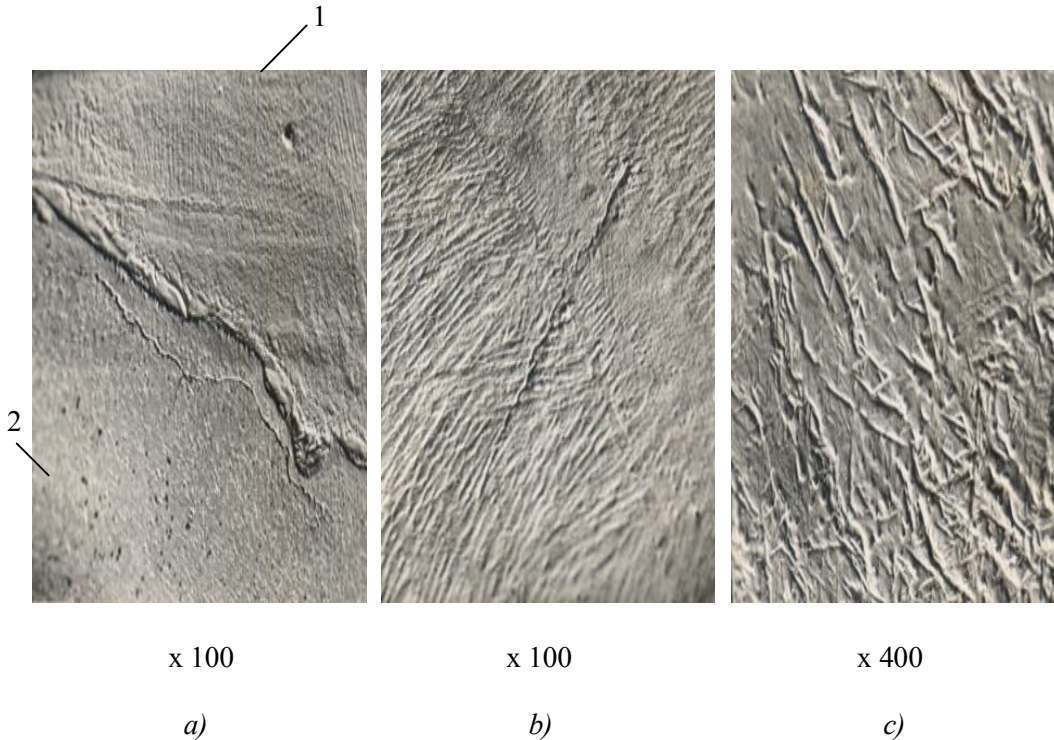
*Fig. 5. Structure of weld metal with PANCH-11 wire cladding and UONI 13/45 electrodes filling:
a – fusion boundary of the cladding layer with the filler;
b – overlapping zone of steel rollers;
c – structure of the filler.
1 – steel aggregate; 2 – lining layer*

The filling of the development on the cladding layer with UONI 13/45 steel electrodes was studied. The surfacing was carried out at a constant current of reverse polarity at $I_w = 140$ A with a $\varnothing 4$ mm electrode. The welding process proceeded stably, the weld formation was satisfactory, and no pores, undercuts, or cracks were detected during visual inspection. The slag crust separation is satisfactory.

At the same time, metallographic studies showed the presence of cracks in both the cladding layer (Fig. 5, a) and the filler (Fig. 5, b). The structure of the steel weld in the fusion line (Fig. 5, c) is a brittle tetragonal martensite along the grain boundaries, which contributes to the formation of cracks in the weld due to welding stresses accompanying the welding process.

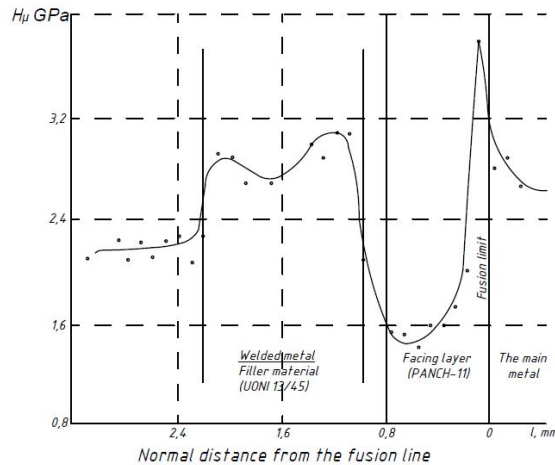
Fig. 6. Change in microhardness along the welded joint sections when surfacing with UONI 13/45 electrodes on PANCH-11 cladding:

The change in microhardness in the welded joint is shown in Fig. 6. The presence of cracks in the cladding layer can be explained by the different shrinkage of the steel roller, which «undermines» the cladding layer and creates a crack in the weld joint.

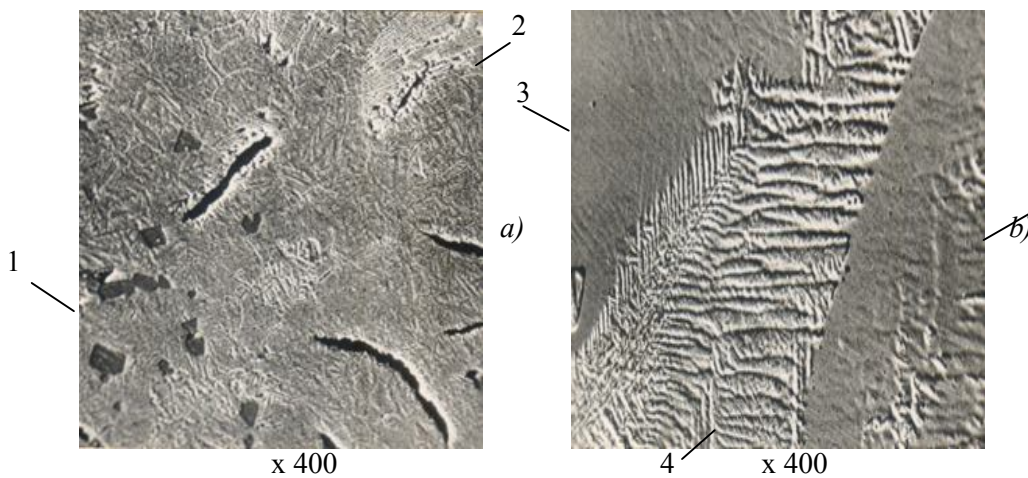
Fig. 7. Structure of weld metal with cladding with PANCH-11 wire and filling with UONI 13/45 electrodes and wire:
a – fusion boundary of the cladding layer with the base metal;
b – mixing zone of ferrite and austenite layers;
1 – base metal; 2 – facing layer; 3 – austenitic layer; 4 – ferrite layer

To reduce the role of the steel component in the weld, a welding method with alternating rolls made of PANCH-11 wire and UONI 13/45 electrodes was investigated. Metallographic studies have confirmed that the mixing of austenitic and ferrite layers eliminates the initiation of cracks in the welded joint. Along the fusion boundary between the cladding layer and the base metal, there are always hardened structures, such as lower bainite and martensite (Fig. 7, a).

Fig. 7, b shows the mixing zone between the ferrite and austenite layers. The microhardness study is shown in Fig. 8.

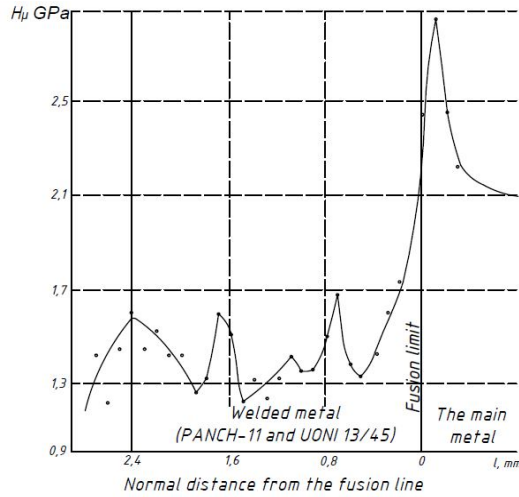
Fig. 8. Change in microhardness of a welded joint with PANCH-11 cladding wire and filling with UONI 13/15 electrodes and PANCH-11 wire:

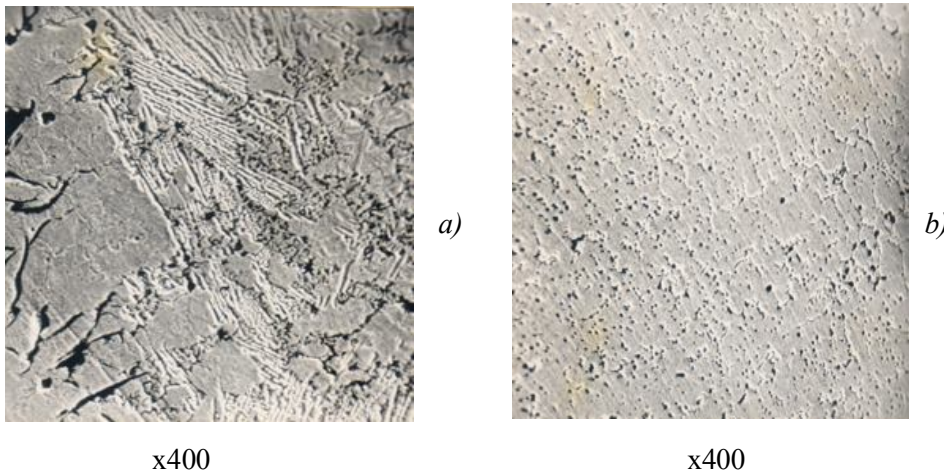
Fig. 9. Microstructure of the welded joint, cut from a cast iron lid:
a - fusion limit; b - deposited layer

In our case, the welding of cast iron samples in a workpiece lined with PANCH-11 wire was carried out over a thin layer of iron or cast iron powder (crumbs). The weld formation is satisfactory. Metallographic studies have confirmed the absence of cracks in the welded joint made on the cover of the 6CH18/22 diesel engine (Fig. 10). The change in microhardness in parts of the welded joint is shown in Fig. 10. The introduction of iron powder into the weld pool increased the hardness of the weld, which will have a positive effect on its strengthening qualities.

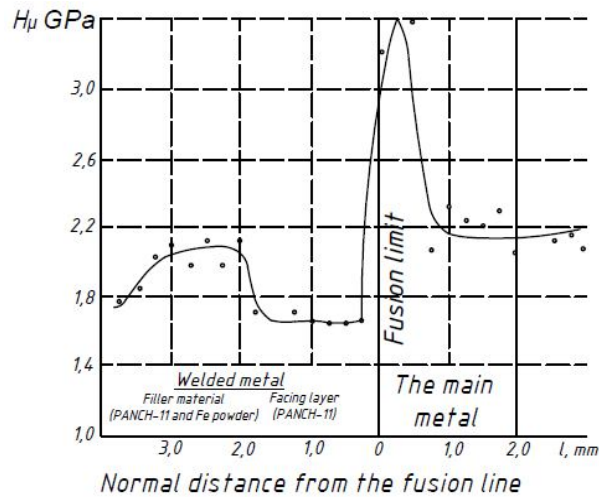
Fig. 10. Graph of changes in the microhardness of sections of a welded joint cut from a cast iron lid:

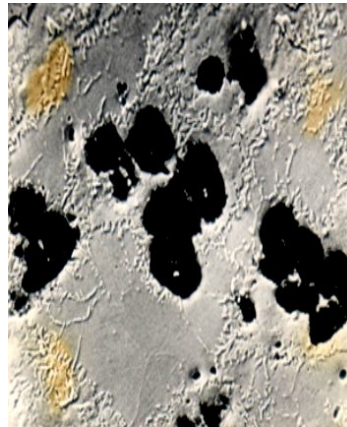
Fig. 11. Structure of high-strength cast iron from the cylinder head of the MAN6Z57/80F diesel engine

The weldability of high-strength cast iron was studied (Fig. 11) on samples cut from the cover of the MAN6Z57/80F diesel engine. Welding was performed by a semiautomatic machine at $I_w = 100 - 180$ A, $U = 18 - 20$ V.

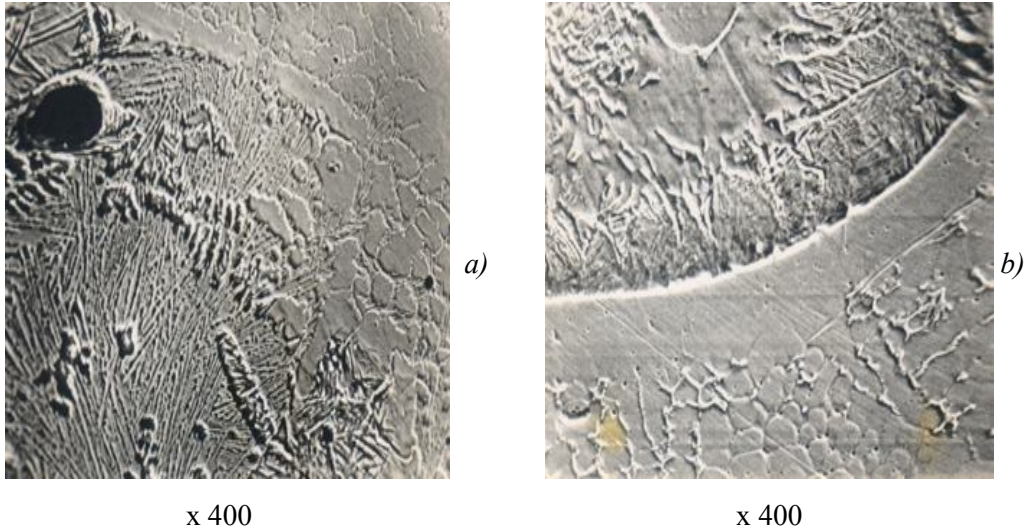
Fig. 12. Microstructure of a welded joint of high-strength cast iron:
a – welding without preheating; b – welding with preheating up to 150 °C

The study of the microstructure showed that there are hardened structures in the heat-affected zone (HAZ) (Fig. 12), but with preheating of the cover to 150° with a gas torch (microhardness values are shown in Fig. 12, b). No cracks in the surfacing and HAZ were found, so this welding method can be recommended for the restoration of the main cylinder covers of the MAN6Z57/80F diesel engine from high-strength cast iron.

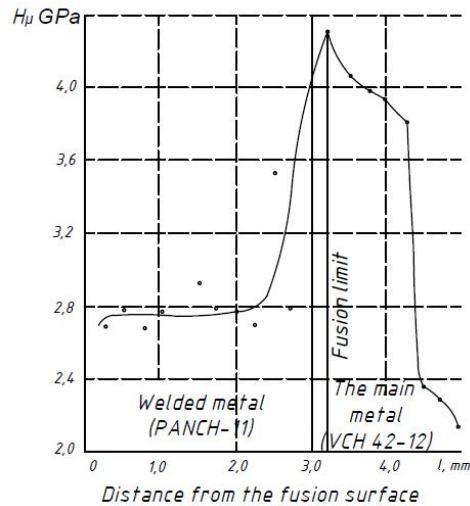
Fig. 13. Graph of microhardness measurements at sections of a high-strength cast iron welded joint (surfacing with preheating to 150 °C):

Microhardness studies are shown in Fig. 13.
